Private Water Crossing Report

FEMA-4219-DR-WV

July 7, 2015

This report was developed by Allen Graybill, FEMA Reservist, who was deployed as a Hazard Mitigation Program Support Manager to the Joint Field Office in Charleston, West Virginia during the response and recovery of FEMA-4219-DR-WV in May 2015.

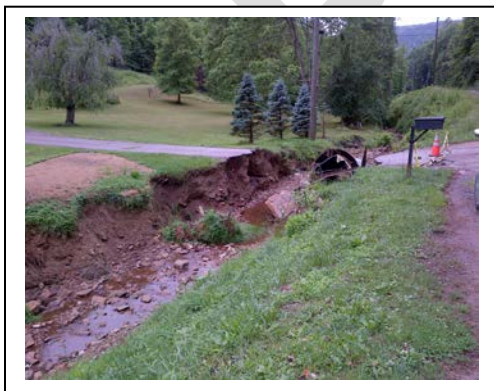
Existing Damage:

Crossing Specifications: With a rented crane, install 4' x 12' box culvert sections for 12' wide crossing with 8 sections of wing walls 2' x 2.5' x 6', two sections per wing with grout. Use back fill and riprap to stabilize banks, repair scoured areas and re-establish approaches.

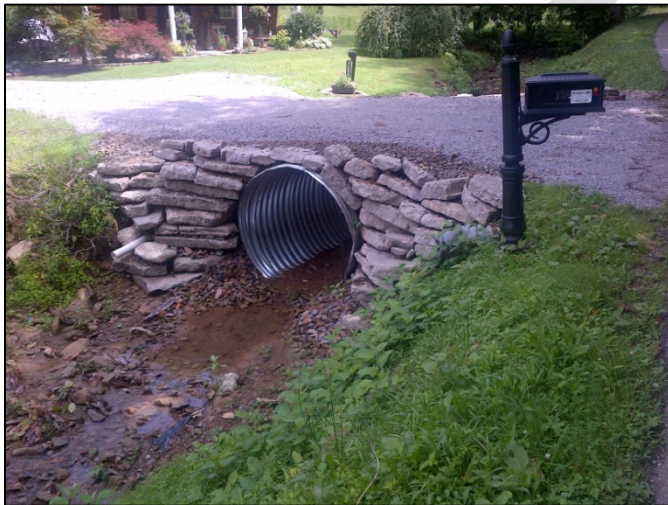
1. Existing culvert was washed out and has been replaced with a new 5'-0" x 20'-0" long metal culvert with head walls, fill and gravel overlay. It is located along Curry Fork. The crossing is for one house. Coordinates: 37.96724°, -81.92696°, elevation: 843'. The listing from the damage assessment sheet is 126 Barker Fork Rd, Chapmanville, WV 25508. That is the mailing address. The physical location is 361 Old Dairy Rd, Chapmanville, WV 25508, Logan County.

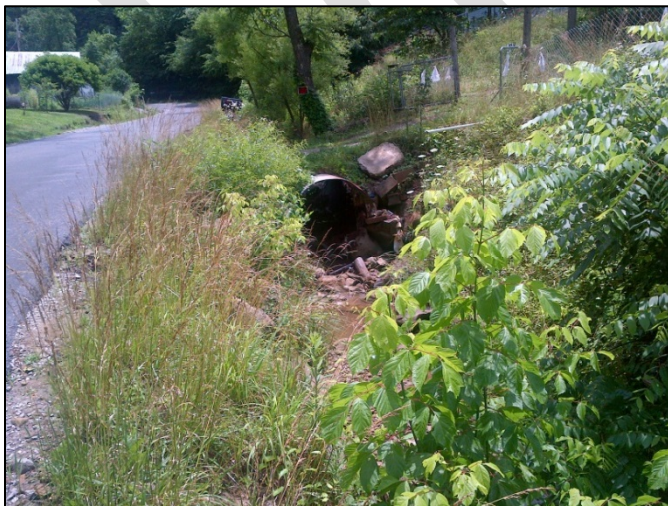
2. This culvert water crossing suffered some erosion. The crossing is for one house as listed on the Damage Assessment Sheet. Coordinates: 37.90733°, -82.13045°, elevation: 893'. Address: 925 Harts Creek Rd, Harts, WV 25524, Logan County.

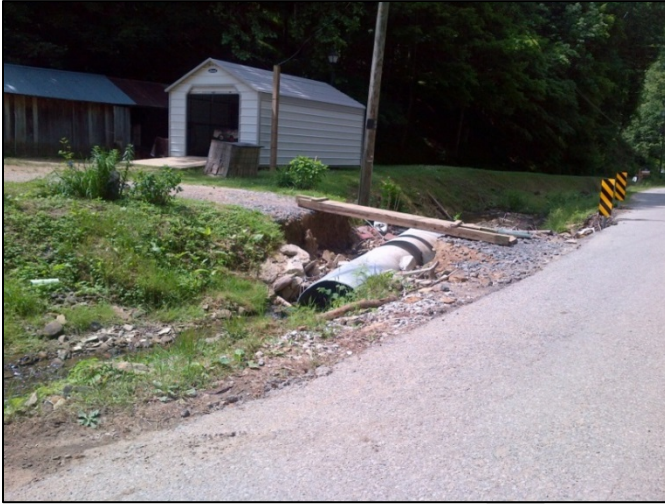
1. This existing metal culvert water crossing was undersized, causing washout, erosion and berm/roadway damage along Little Horse Creek. This crossing services one home. Coordinates: 38.14030°, -81.85508°. Address: 2548 Little Horse Creek Road, Julian, WV 25529, Boone County.

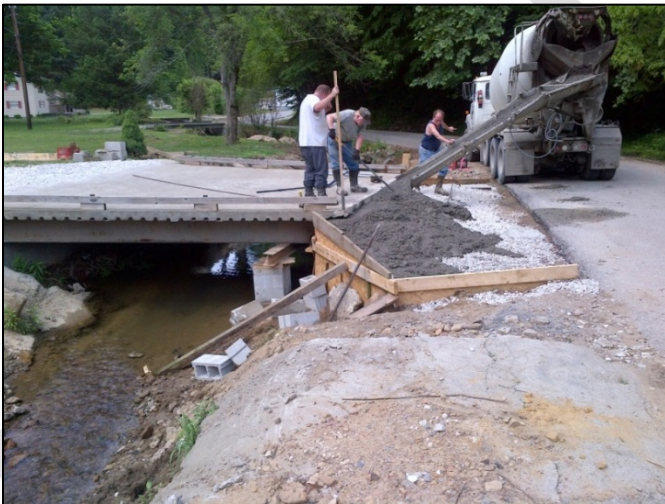
2. This bridge collapsed at one end, concrete deck end broke off, erosion, scouring, and loss of bridge approach along Little Horse Creek. Bridge jacked up with temporary supports while new concrete supports, decking, approach and wing walls are poured. Bridge services one home. Coordinates: 38.15130, -81.86170°. Address: 690 Little Horse Creek Road, Julian, WV 25529, Boone County.

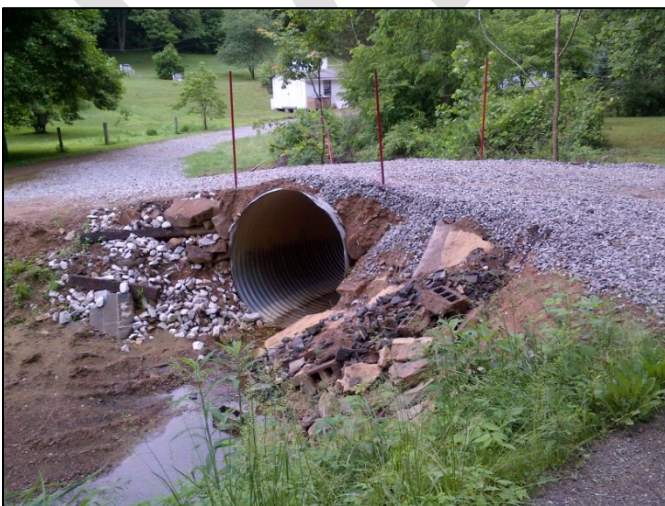
3. This water crossing has been repaired and culvert replaced along White Oak Branch of Big Coal River. The crossing is for one house, not three as listed. Coordinates: 38.17849°, -81.72768°, elevation: 665'. Address: The listing from the damage assessment sheet is 1776 Lower White Oak Rd, Ashford, WV 25009. It is actually located at 1526 Lower White Oak Rd., Boone County.

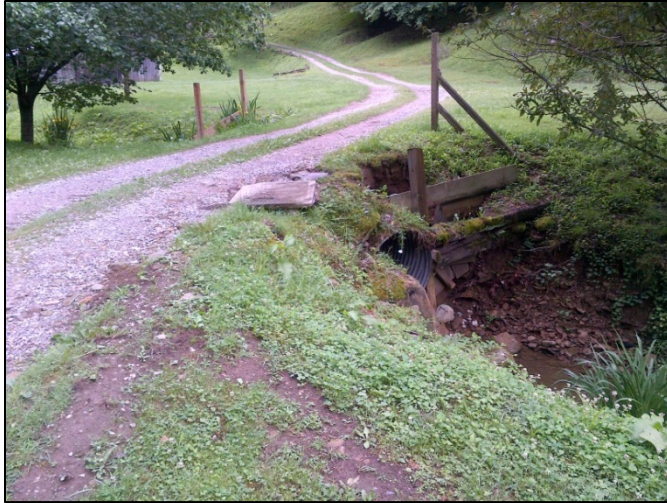
4. This shows erosion around a corrugated metal culvert along Sugar Camp Branch of Camp Creek. This crossing services one home.

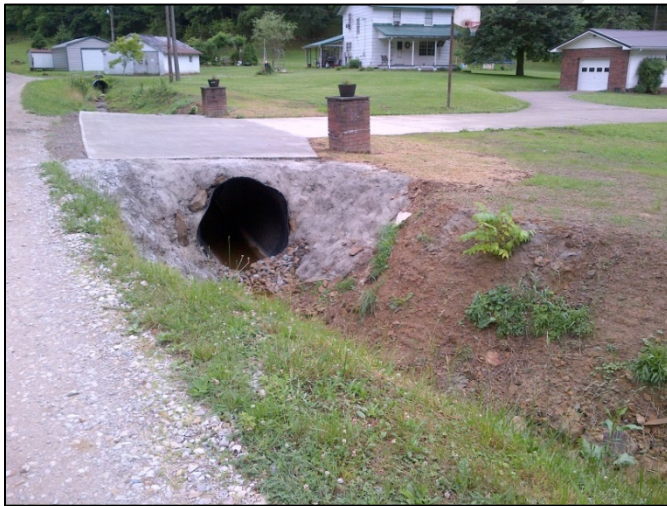
5. This washed out corrugated metal culvert replaced with new corrugated 4'-0" pipe by homeowner with concrete and soil bank stabilization and grading along Sugar Camp Branch of Camp Creek. This crossing services one home. Coordinates: 38.11523°, -81.77533°, elevation: 769'. Address: 64 Herman Hollow Road, Julian, WV 25529, Boone County.

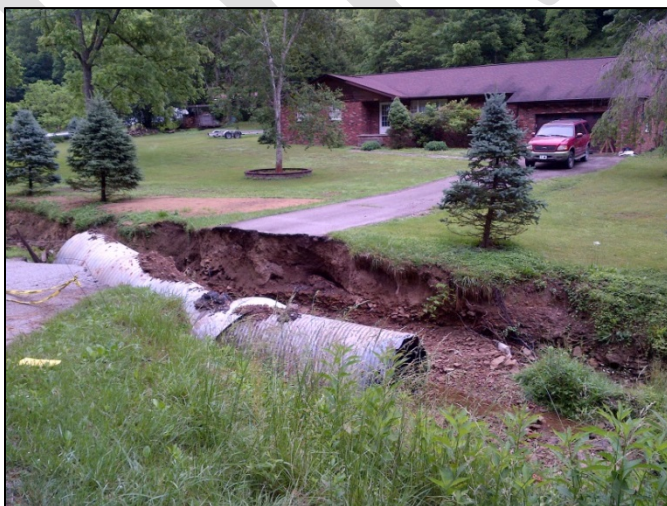
6. This existing metal culvert water crossing was severely washed out along Lefthand Fork of Camp Creek. This crossing services one home. This washed out corrugated metal culvert could be replaced by a bridge with site space permitting wing walls and structure clear of waterway.

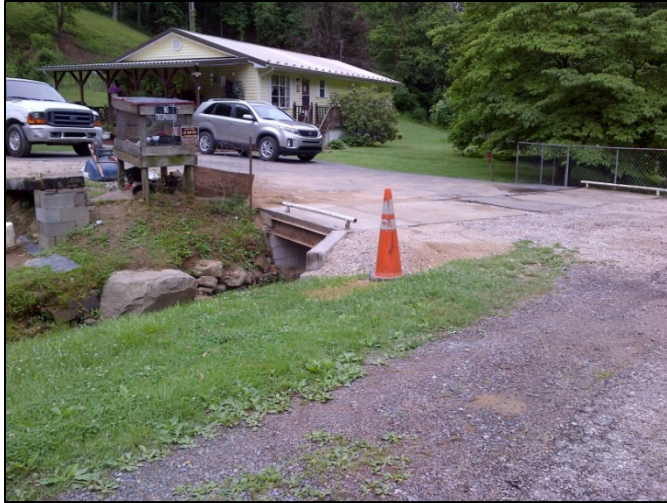
7. This damaged water crossing has been repaired with steel beams, concrete decking and concrete block along Lefthand Fork of Camp Creek. This crossing services one home. Coordinates: 38.13049°, -81.78834°, elevation: 900'. Address: 1442 Easter Hollow Road, Ridgeview, WV 25169, Boone County.

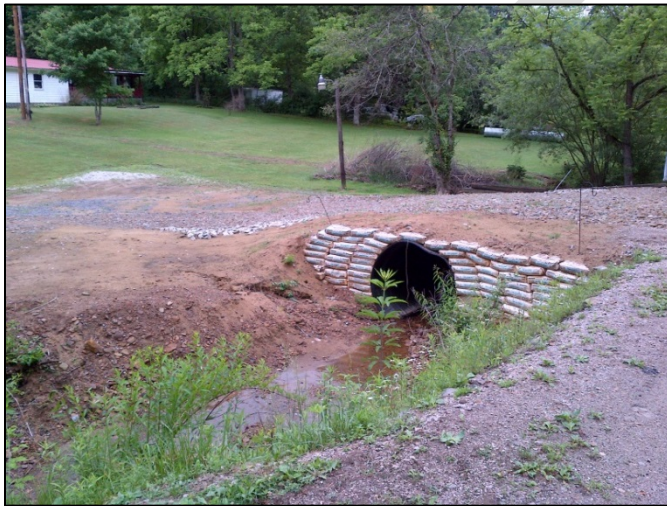
8. This damaged water crossing has been repaired with inlet and outlet headwalls composed of stacked concrete bags, new metal culvert and gravel with grading and stream bank stabilization along Lefthand Fork of Camp Creek. This crossing services two homes. Coordinates: 38.12823°, -81.79046°, elevation: 836'. Address: 1094 & 1054 Easter Hollow Road, Ridgeview, WV 25169, Boone County.

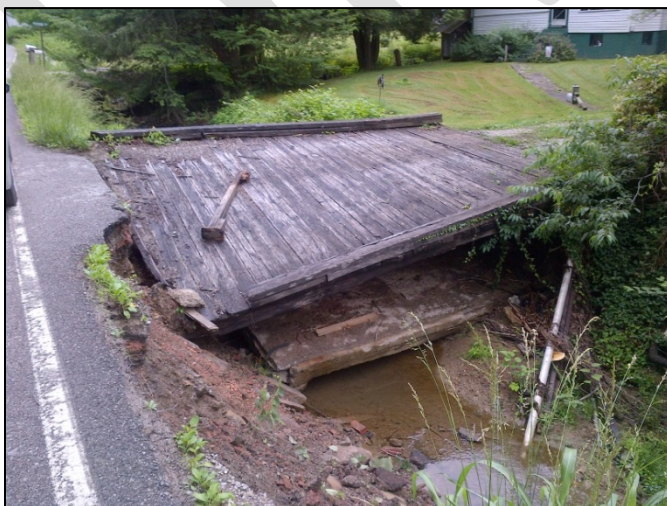
9. This bridge suffered severe damage along Brush Creek with collapse at one end, scouring, partial loss of bridge approach and bank erosion. Bridge services two homes. This site is not listed on the Damage Assessment Sheet. Coordinates: 38.12725°, -81.75713°, elevation: 882'. Address: Ridgeview Nellis Road (Rt. 1), Ridgeview, WV 25169, Boone County.

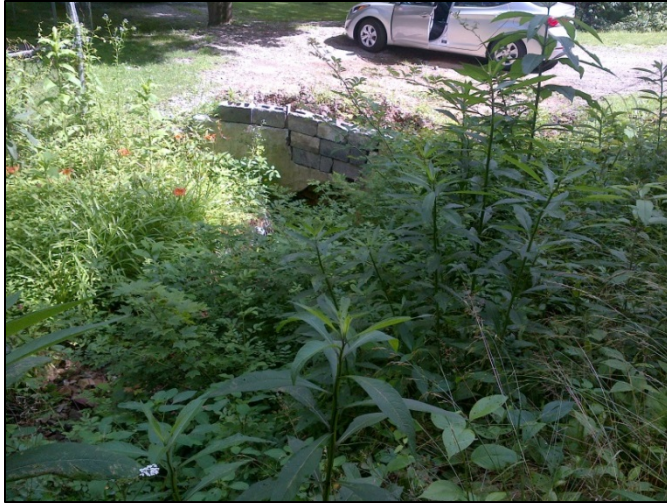
10. This culvert crossing had some erosion problems along tributary to Brush Creek. The crossing is for one home. Coordinates: 38.13757°, -81.76521°, elevation: 779'. Address: The listing from the damage assessment sheet is 726 Ridgeview Hollow Rd, Ridgeview, WV 25169, Boone County.

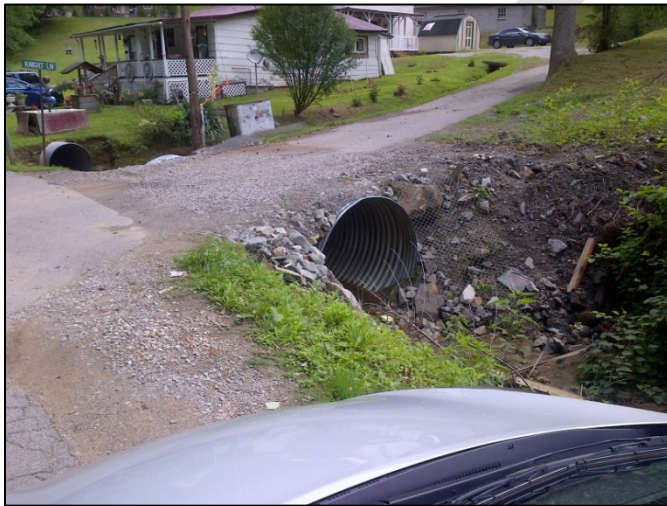
11. This washed out corrugated metal culvert replaced with new corrugated pipe along Toney Fork of Drawdy Creek. Coordinates: 38.10643°, -81.73255°, elevation: 904'. Address: 86 Knight Lane, Peytona, WV 25154, Boone County.

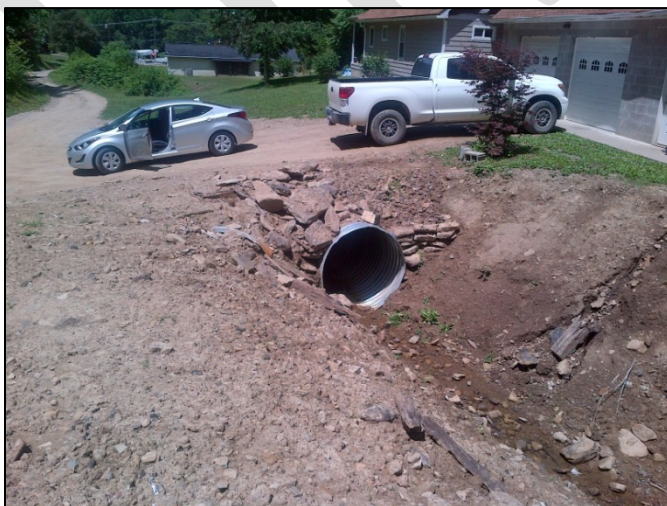
12. This washed out corrugated metal culvert replaced with new 4' corrugated culvert along feeder to Big Coal River. Coordinates: 38.11144°, -81.620057°, elevation: 767'. Address: 197 Oakdale Lane, Seth, WV 25181, Boone County.

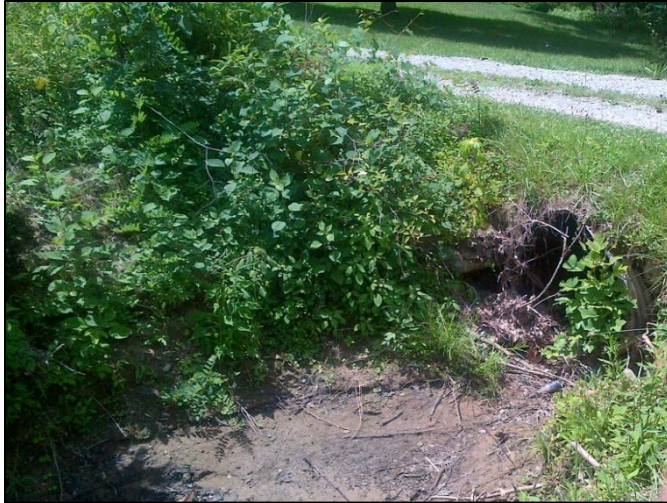
13. This culvert crossing had no obvious problems upon inspection. Debris needs cleaned out with regular maintenance provided. The crossing is for one home. Coordinates: 38.11811°, -81.59311°, elevation: 743'. Address: 3329 Joes Creek Road, Comfort, WV 25049, Boone County.

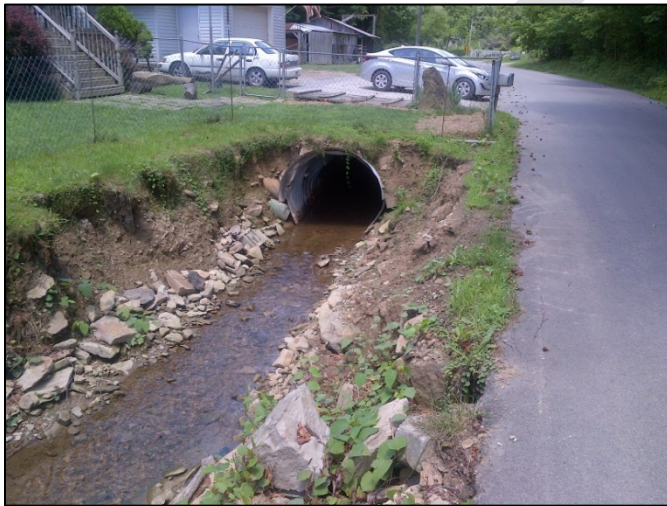
14. This property had another connecting culvert that washed out with yard and fence along Toney's Creek. Bridge crossing where cars are parked was constructed post event. The crossing is for one home. Coordinates: 38.14989°, -81.62437°, elevation: 717'. Address: 1485 Toney's Branch Road, Comfort, WV 25049, Boone County.

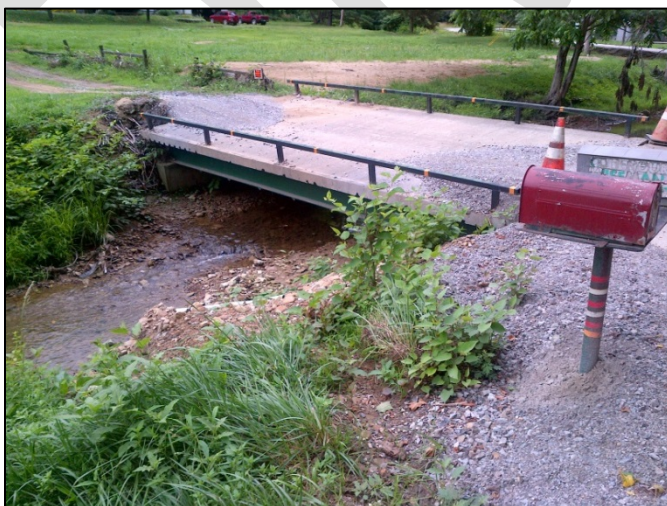
15. This bridge suffered damage along Lick Creek with erosion, scouring, abutment instability and collapse. Bridge services two homes and is owned by one person. This site is a dangerous crossing now. Coordinates: 38.08321°, -82.86253°, elevation: 690'. Owners address: 85 Wiseman Lane (along Lick Creek Rd), Danville, WV 25524, Boone County. Owner at 147 Wiseman Lane temporarily also uses the bridge.

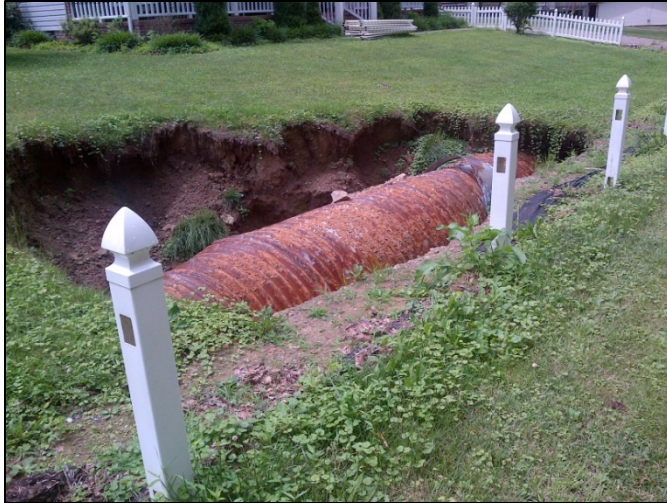
16. The yard washed out at this property along Toney's Creek. Erosion and scouring took place around this culvert pipe. The crossing below was not affected and is for one home. Coordinates: 38.07480°, -81.87540°, elevation: 746'. Address: 234 Left Fork Lick Creek Rd, Danville, WV 25053, Boone County.

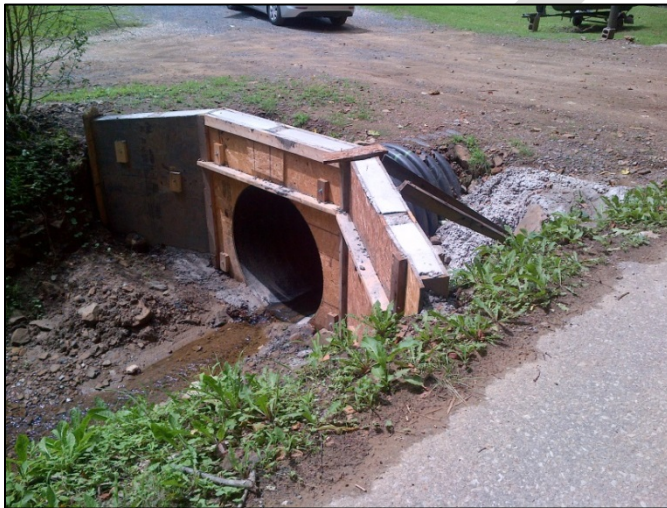
17. This washed out crossing has been replaced with a plastic pipe and poured, formed concrete head and wing walls. This site is still under construction along Trace Branch of Big Ugly Creek. The crossing is for two homes. Coordinates: 38.07370°, -81.87553°, elevation: 714'. Address: 384 Left Fork Lick Creek Rd, Danville, WV 25053, Boone County.

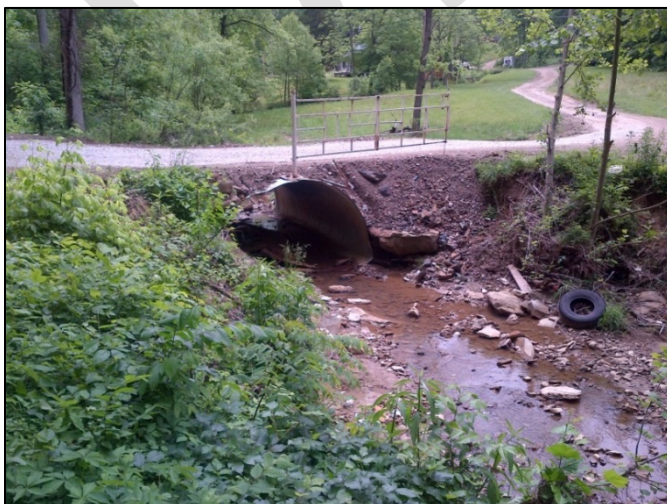
1. This washed out corrugated metal culvert replaced with new corrugated 5'-0" pipe by homeowner with bank stabilization and gravel, grading along Big Ugly Creek. No obvious mitigation. Destroyed pipe visually located nearby. This crossing services one home. The coordinates: 38.03064°, -81.93813°; elevation: 983'. Address is 2107 Big Ugly Creek Road, Harts, WV 25524, Lincoln County.

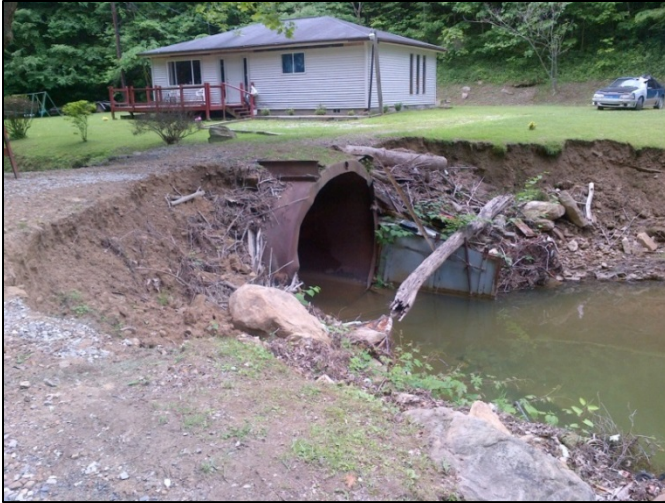
2. This existing metal culvert, an altered fuel storage tank suffered bank erosion and is need of repairs along East Fork of Fourteenmile Creek. This crossing services one home. The coordinates are: 38.08443°, -82.16602°; elevation: 710'. Address interpolated from Damage Assessment Sheet as 2313 McClellan Highway (RT 10), Ranger, WV 25557, Lincoln County.

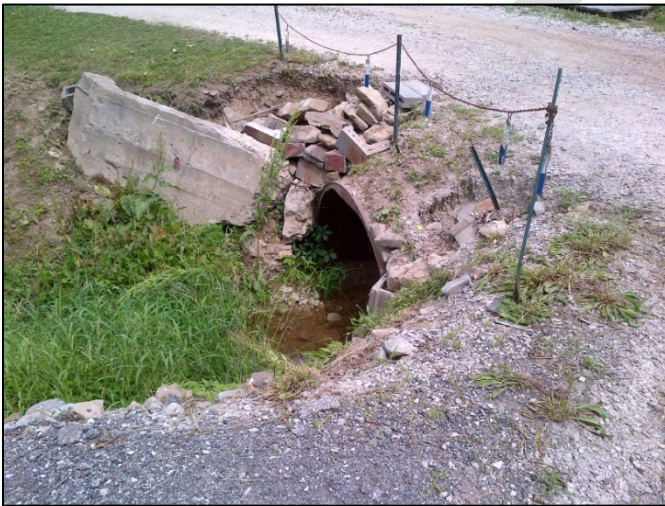
3. This culvert water crossing, an altered fuel storage tank, suffered bank erosion that has been partially addressed along the Laurel Fork of Little Harts Creek. The crossing is for three houses as listed on the Damage Assessment Sheet. Coordinates: 38.01767°, -82.17582°; elevation: 749'. Addresses: 4, 8 and 12 Daddy's Acres (68/1), Harts, WV 25524, Lincoln County.

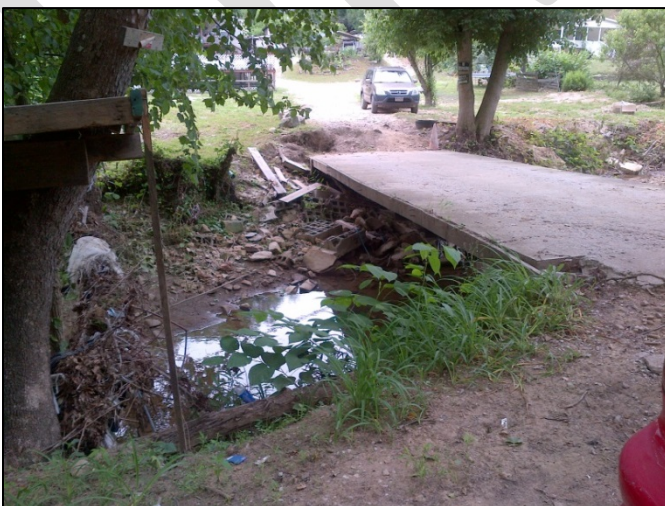
4. Bridge damage along Little Harts Creek with abutment collapse, scouring, partial loss of bridge approach and erosion. Bridge services three homes and four families, one child with special needs. Flood in 1996 destroyed wooden bridge and FEMA IA provided \$1,500.00 towards replacing bridge. The coordinates: 38.04232°, -82.15228°; elevation: 604'. Address: 11, 15 and 24 Bradley Drive (Rt. 68), Harts, WV 25524, Lincoln County.

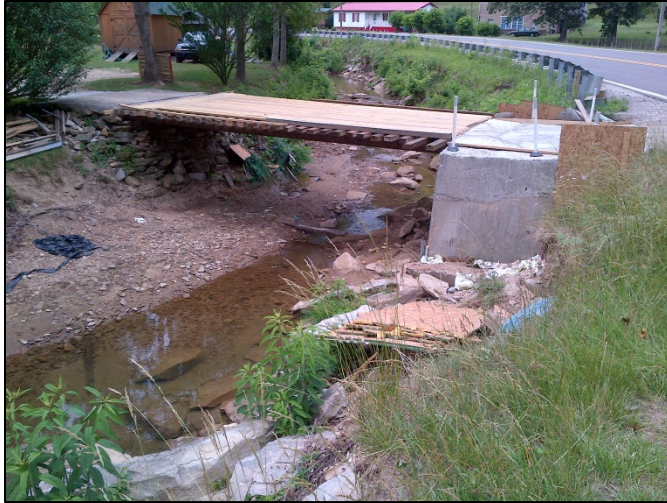
5. Bridge damage along Fourteenmile Creek with abutment collapse at road end, partial loss of bridge approach, deck damage and erosion. Owner completed repairs with new abutment and decking. Existing stone abutment is of questionable structural integrity. Bridge services one home. Coordinates: 38.09179°, -82.19294°; elevation: 628'. Address: 315 East Lynn Road (Rt. 37), Ranger, WV 25557, Lincoln County.

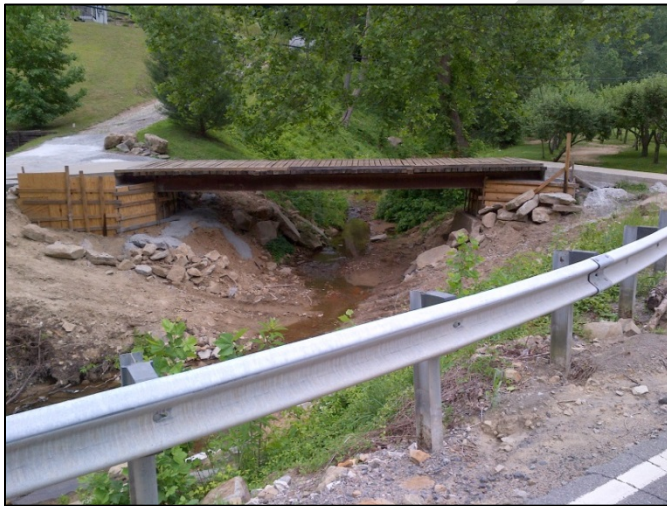
6. This site along Fourteenmile Creek had a washed out bridge with unknown erosion and scouring. Complete new bridge constructed with new wood decking and concrete approaches and abutments with wing walls adequately set back from water course. Bridge services three homes. Coordinates: 38.09075°, -82.19310°; elevation: 671'. Address: 325 East Lynn Road (Rt. 37), Ranger, WV 25557, Lincoln County.

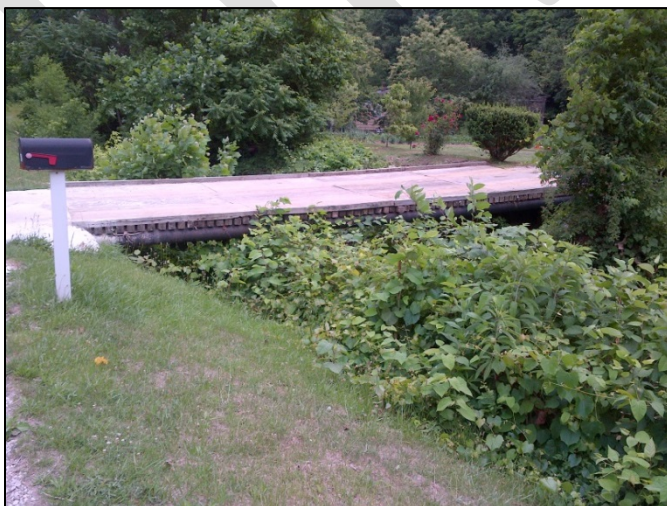
7. This site along Fourteenmile Creek reportedly had a washed out bridge with unknown erosion and scouring. Existing bridge constructed with new wood decking, including plywood and concrete approach. Existing metal pipe beams reused. Bridge services one home. The coordinates are: 38.08751°, -82.20121°; elevation: 690'. Address: 463 East Lynn Road (Rt. 37), Ranger, WV 25557, Lincoln County.

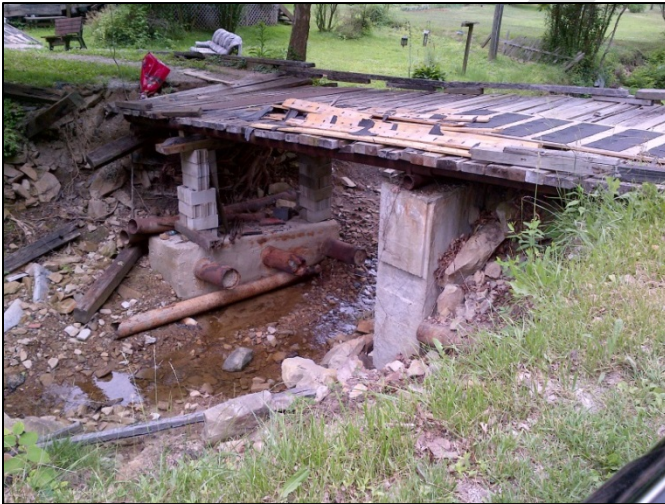
9. This bridge suffered damage along Fourteenmile Creek with severe damage, erosion and maintenance issues. Owner completed repairs with new abutment and decking. Bridge services one home. Coordinates: 38.08850°, -82.20808°; elevation: 686'. Address: 551 East Lynn Road (Rt. 37), Ranger, WV 25557, Lincoln County.

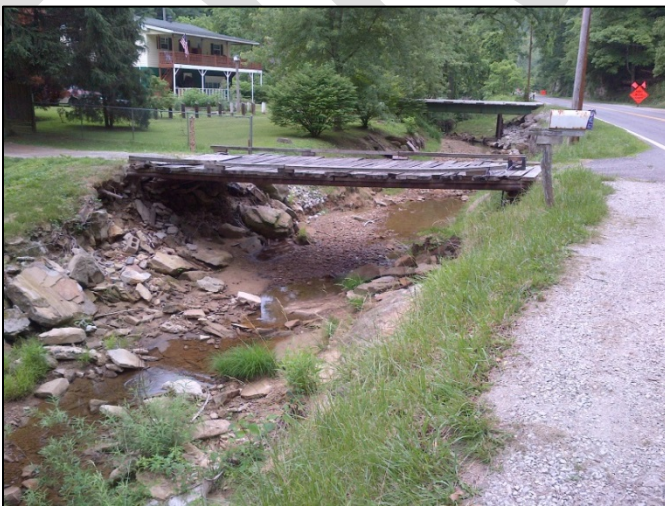
10. This bridge suffered damage along Fourteenmile Creek with erosion, scouring, abutment instability and maintenance issues. Minimally, new abutments and bank stabilization required. Bridge services one home. Coordinates: 38.08792°, -82.19865°; elevation: 655'. Address: 441 East Lynn Road (Rt. 37), Ranger, WV 25557, Lincoln County.

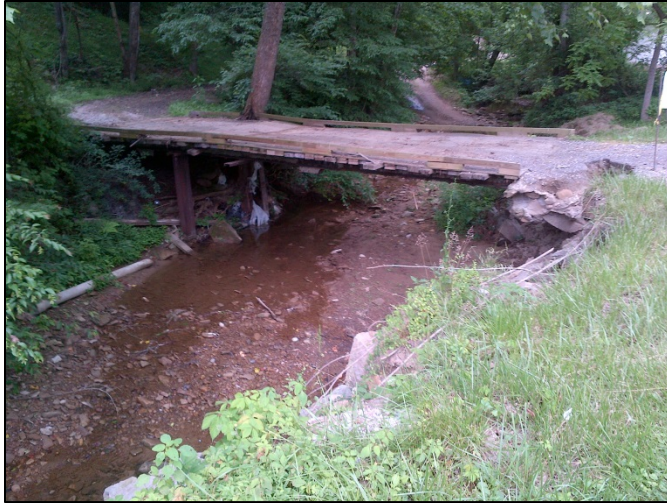
11. This bridge suffered damage along Fourteenmile Creek with erosion, scouring, abutment instability and maintenance issues. The bridge is no longer passable and a low water crossing was established alongside the bridge. Minimally, new abutments and bank stabilization required. Bridge services one home. Coordinates: 38.08808°, -82.19587°; elevation: 655'. Address: 427 East Lynn Road (Rt. 37), Ranger, WV 25557, Lincoln County.

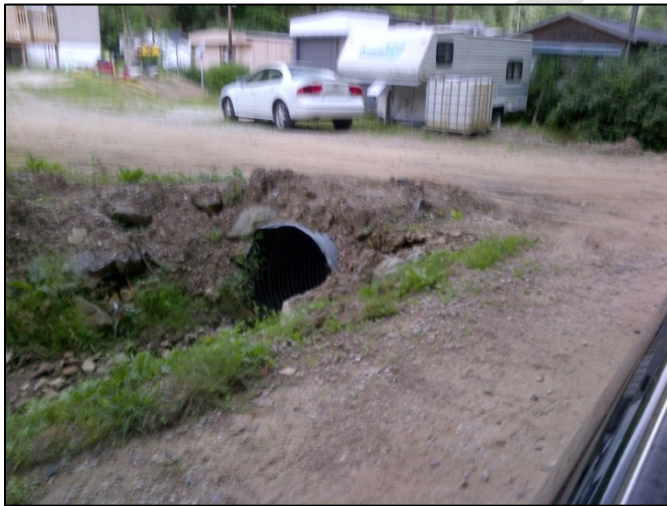
12. This culvert crossing has been repaired along Trace Branch of Big Ugly Creek. This culvert damage is a reoccurring problem. The crossing is for at least five residences, seven families are listed on original assessment sheet. Coordinates: 38.03089°, -81.95580°; elevation: 929'. Address: The listing from the damage assessment sheet is 67 Estep Drive Branch, Harts, WV 25524, Lincoln County.

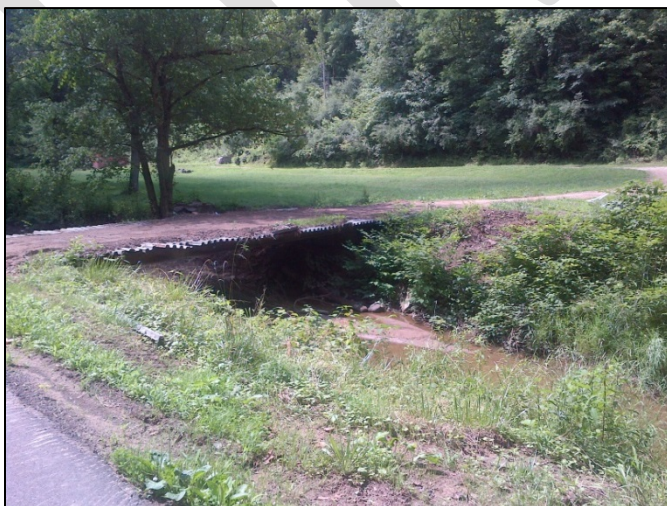
13. This bridge suffered damage along East Fork of Big Harts Creek. Abutments and Bank stabilization required. Bridge services one home. Coordinates: 38.00678°, -82.10885°; elevation: 606'. Address: 424 East Fork Road (Rt 70), Harts, WV 25524, Lincoln County.

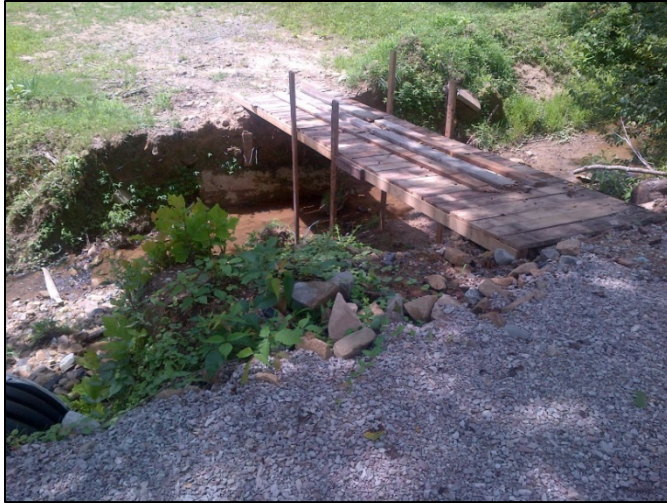
14. This water crossing was completely washed out along Big Ugly Creek. Temporary walking bridge has been installed. This crossing services one home. The coordinates are: 38.01494°, -82.15054°; elevation: 795'. Address: 1158 Big Branch Road, Harts, WV 25524, Lincoln County.

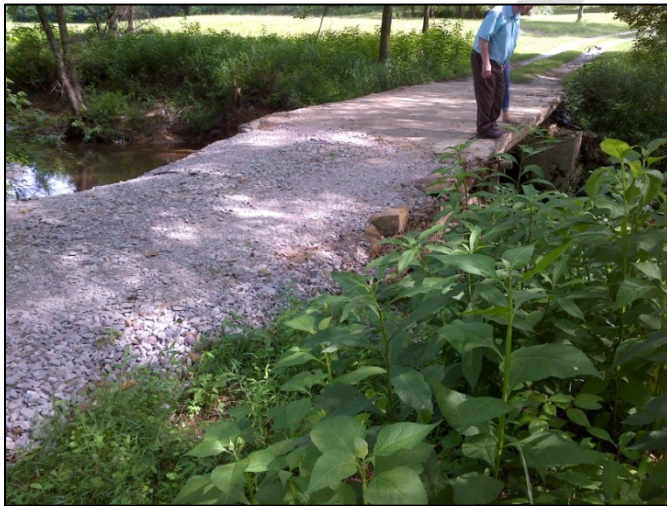
15. This bridge suffered damage along Gartin Fork. Access and approaches on both sides of bridge washed out and repaired. Bridge services one home. Coordinates: 38.17297°, -82.16717°; elevation: 445'. Address: 28 Jacquelyn Lane, Midkiff, WV 25540, Lincoln County.

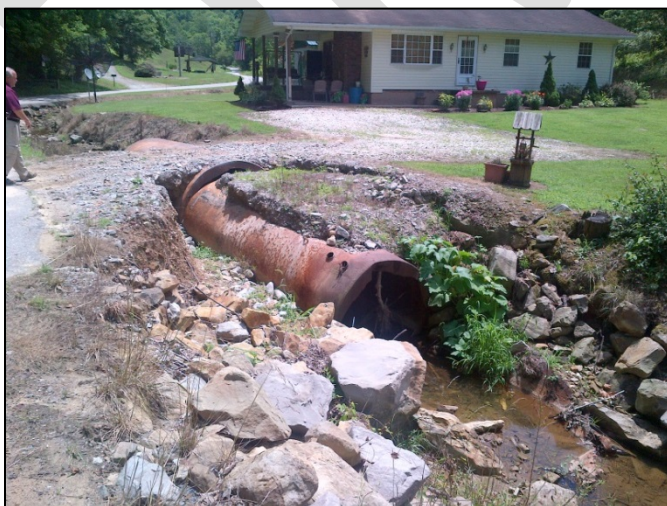
16. This culvert water crossing, an altered fuel storage tank, was washed out along Coal Branch of Big Harts Creek. This crossing services one home. Coordinates: 38.00984°, -82.12967°; elevation: 602'. Address: 37 Coal Branch Road (19/1), Harts, WV 25524, Lincoln County.

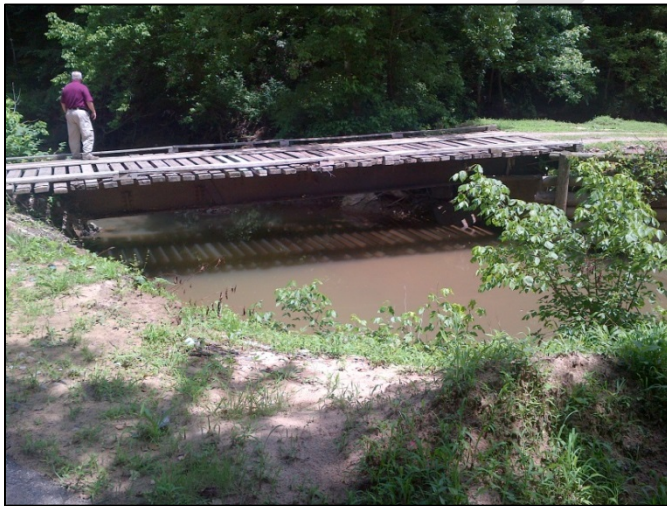
18. This bridge suffered erosion damage at abutments along Big Harts Creek. Bridge services three homes. Coordinates: 38.17297°, -82.16717°; elevation: 445'. Address: 35, 49 and 59 Caney Branch Road, Harts, WV 25524, Lincoln County.

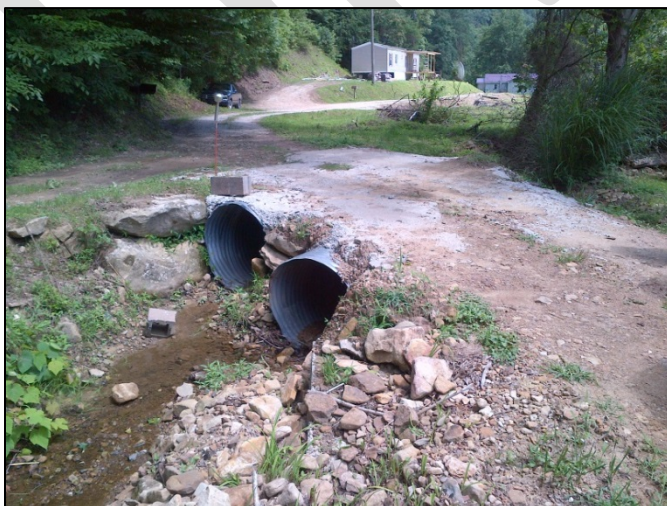
19. This gang culvert water crossing and private dirt roadway was washed out along Mudlick Branch. Culverts and fill were replaced with some rock head wall placement completed. This crossing services one home. Coordinates: 38.03699°, -82.18686°; elevation: 755'. Address: 85 Mudlick Road, Harts, WV 25524, Lincoln County.

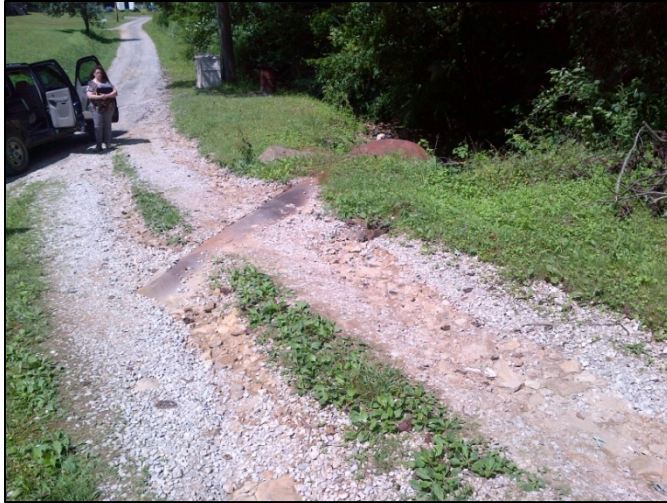
20. This culvert water crossing and private dirt roadway was washed out along Gartin Fork of Mudlick Branch. This crossing services one home. Coordinates: 38.02739°, -82.18564°; elevation: 750'. Address: 85 Gartin Fork Road, Harts, WV 25524, Lincoln County.

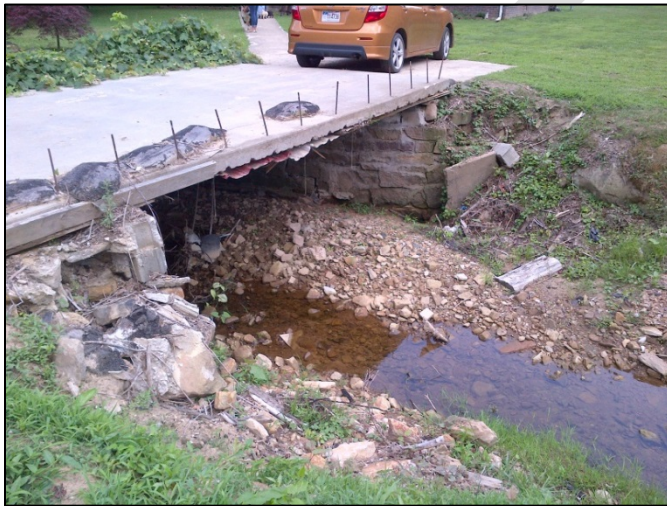
21. This bridge suffered damage along Steer Fork. Abutments and Bank stabilization required. Bridge services one home. The coordinates: 38.08659°, -82.20468°; elevation: 666'. Address: 3 & 7 Steer Fork Road, Ranger, WV 25557, Lincoln County.

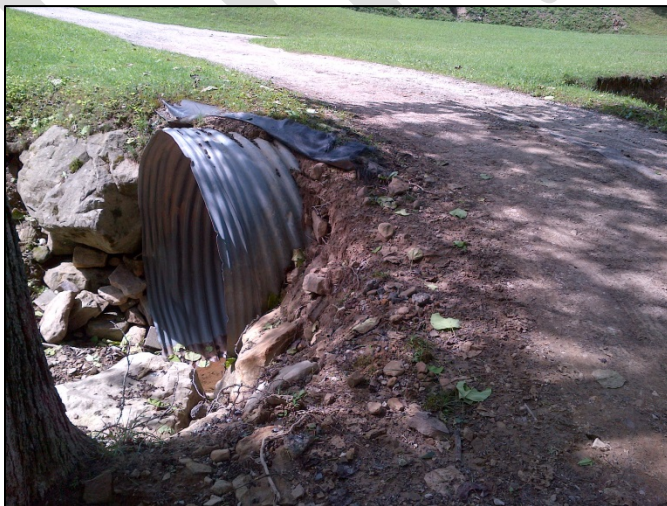
22. This metal culvert suffered erosion damage along Steer Fork. Repairs needed to head walls. Crossing services one home. The coordinates: 38.08320°, -82.20692°; elevation: 714'. Address: 70 Steer Fork Road, Ranger, WV 25557, Lincoln County.

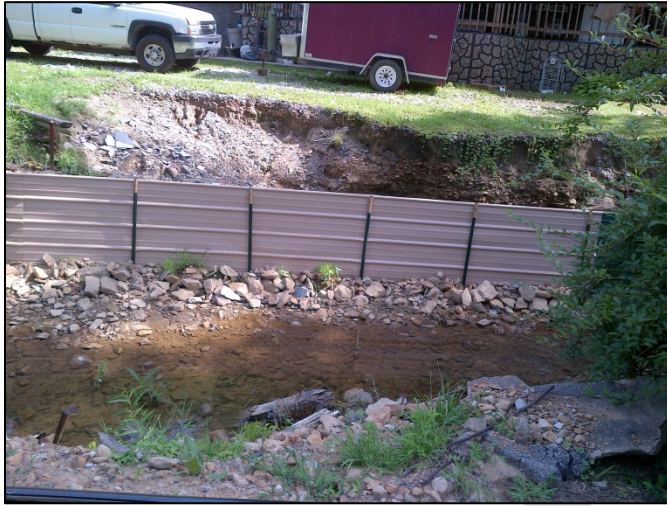
23. This water crossing washed away along Aarons Creek. Replacement needed. Crossing services one home. Coordinates: 38.11480°, -82.15367°; elevation: 639'. Address: 120 Aaron's Creek Road, Ranger, WV 25557, Lincoln County.

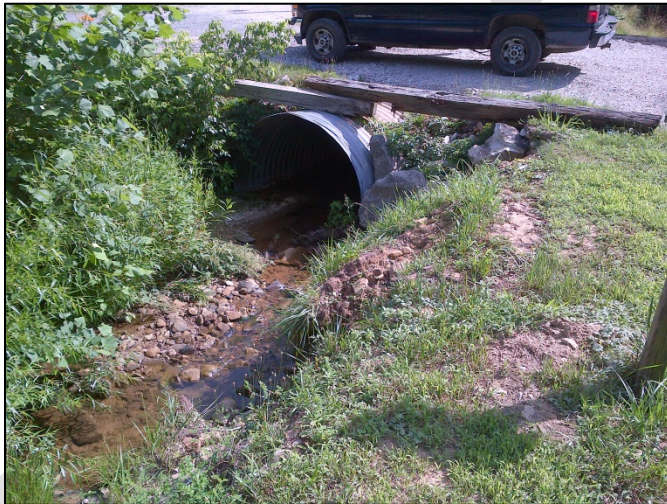
24. This metal culvert was washed out and replaced along Aarons Creek. Crossing services two homes. Coordinates: 38.11484°, -82.15316°; elevation: 644'. Address: 130 & 140 Aaron's Creek Road, Ranger, WV 25557, Lincoln County.

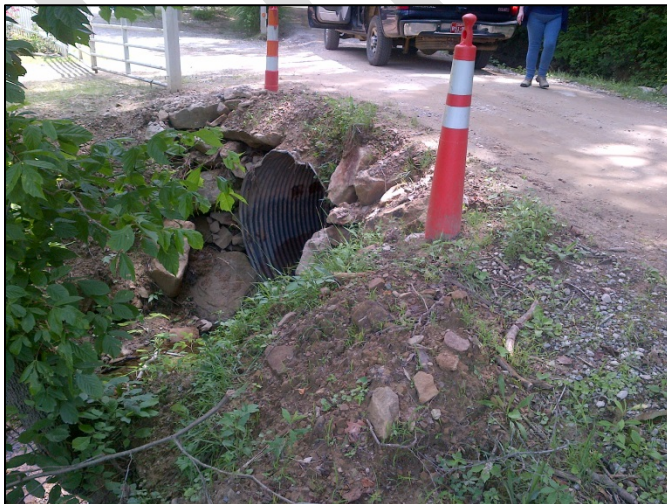
25. This metal culvert was washed out and replaced along the Big Branch of the Big Ugly Creek. Crossing services one home. The coordinates are: 38.080232°, -82.08422°; elevation: 662'. Address: 9 Sperry Hollow Road, Ranger, WV 25557, Lincoln County.

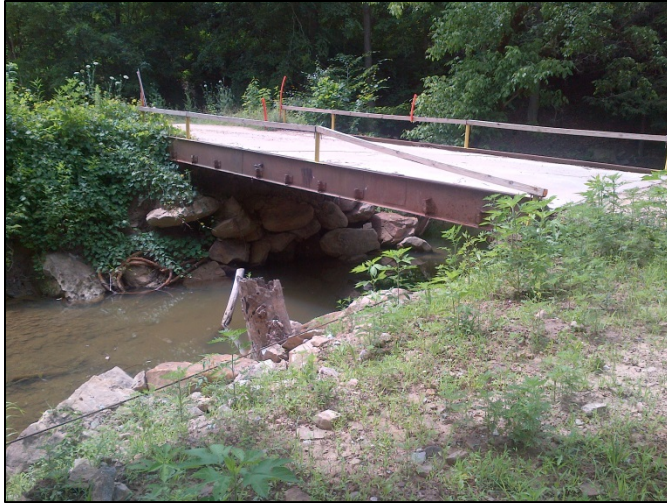
26. This bridge partially collapsed and suffered scouring and erosion damage at abutments along Big Ugly Creek. Bridge was reused with new abutments constructed and rock added. Bridge services four homes. Coordinates: 38.03704°, -82.04849°; elevation: 650'. Address: 9, 13, 17 and 21 Hillclimb Road, Harts, WV 25524, Lincoln County.

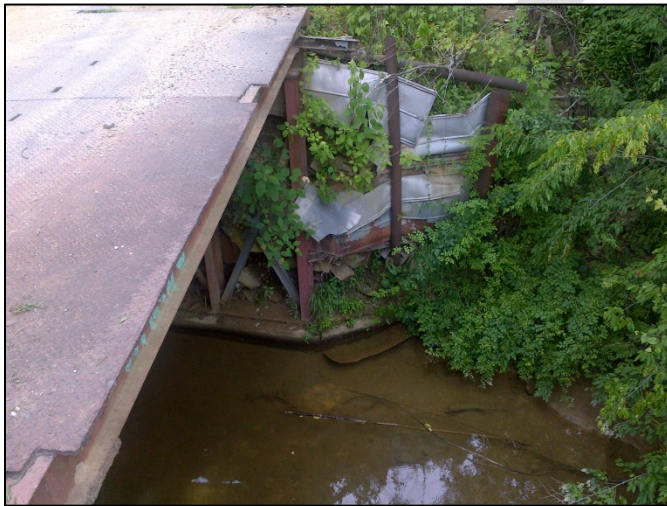
27. This bridge suffered scouring and erosion damage at abutments along Kiah Creek. Bank erosion and scouring around abutments needs repaired. Bridge services three homes. Coordinates: 38.00372°, -82.23414°; elevation: 789'. Address: 18, 21 and 25 Witcher Road, Harts, WV 25524, Lincoln County.

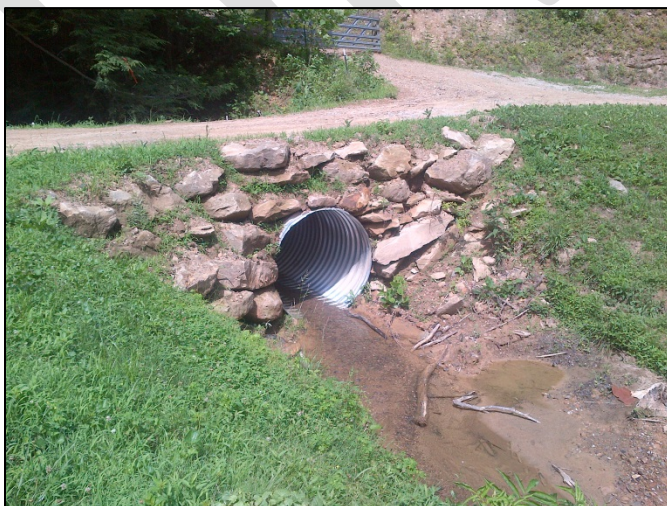
28. This metal culvert was washed out and replaced with a new metal culvert and stone headwalls along Witcher Fork of Kiah Creek. Crossing services one home. The coordinates are: 38.00372°, -82.23479°; elevation: 787'. Address: 25 Witcher Road, Harts, WV 25524, Lincoln County.

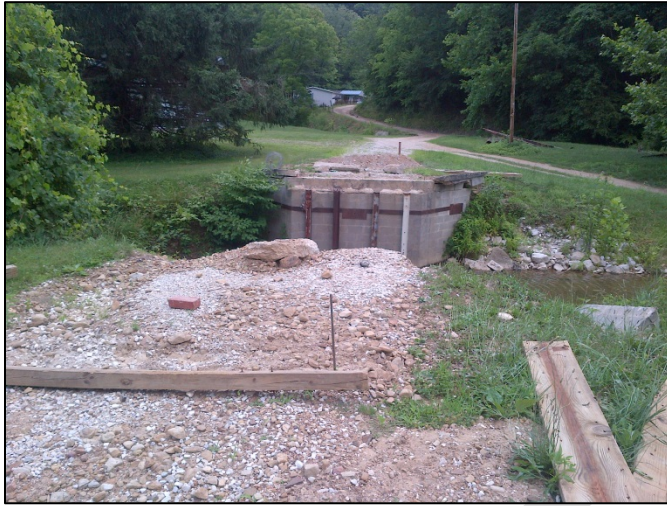
29. This bridge crossing was washed away by log/debris and flood water leaving behind concrete block abutments/wing walls along Fourmile Creek. Bridge services four homes. Families now use a low water crossing for access. New bridge decking secured to existing abutments needed. Coordinates: 38.173279°, -82.236829°. Address: 21, 32, 74 and 76 Watts Family Ct, Branchland, WV 25506, Lincoln County.

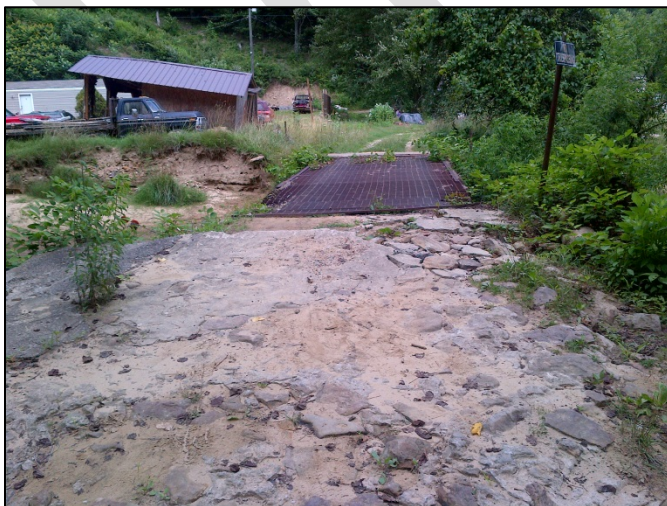
31. This metal grate bridge crossing was damaged along Laurel Creek. Bridge services one home. Coordinates: 38.07250°, -82.06892°; elevation: 635'. Address: 120 Laurel Creek Rd, Harts, WV 25524, Lincoln County.

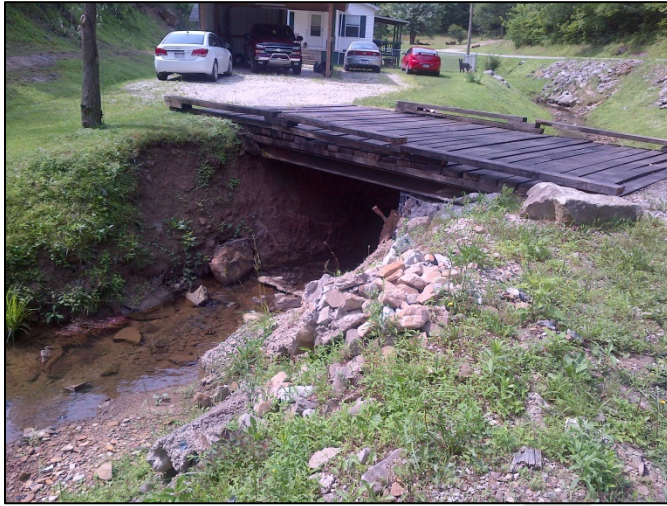
32. This wood deck bridge crossing was damaged along the Jim Branch of Francis Creek. Scouring and erosion of creek banks around abutments occurred. Bridge services one home. Coordinates: 38.07250°, -82.06892°; elevation: 817'. Address: 165 Jim Branch Rd, Harts, WV 25524, Lincoln County.

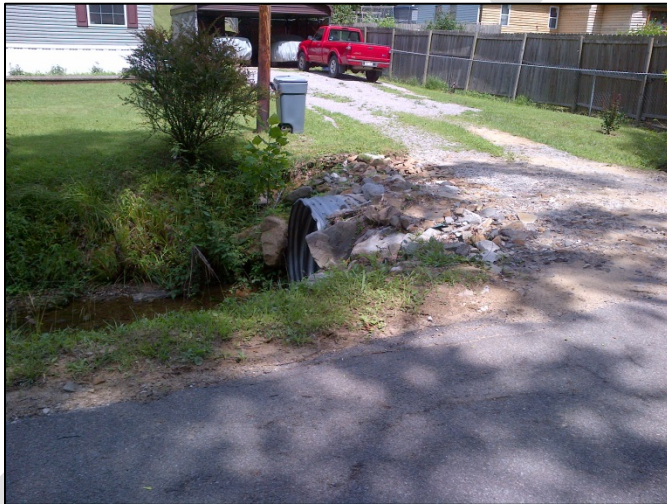
33. This culvert water crossing suffered erosion along the Laurel Fork of Canoe Creek Fork. The crossing is for one house. The coordinates are: 38.02670°, -82.07320°; elevation: 816'. Addresses: 213 Green Shoals Road, Harts, WV 25524, Lincoln County.

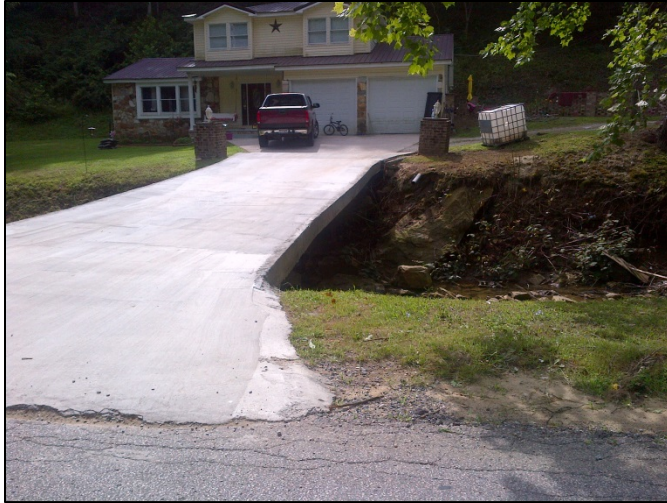
35. This site's bridge crossing was damaged along Little Harts Creek. There was bank erosion and scouring around abutments. Bridge services one home. The coordinates: 38.03841°, -82.15703°. Address: 238 Little Harts Creek Road, Harts, WV 25524, Lincoln County.

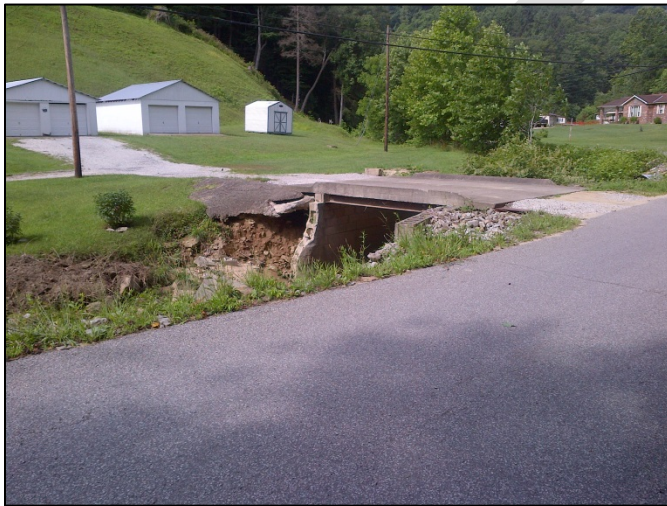
36. This site's bridge crossing was damaged along Little Harts Creek. There is washed out wing walls, bank erosion and scouring around abutments. Bridge services one home. The coordinates are: 38.03398°, -82.16962°; elevation: 731'. Address: 415 Little Harts Creek Road, Harts, WV 25524, Lincoln County.

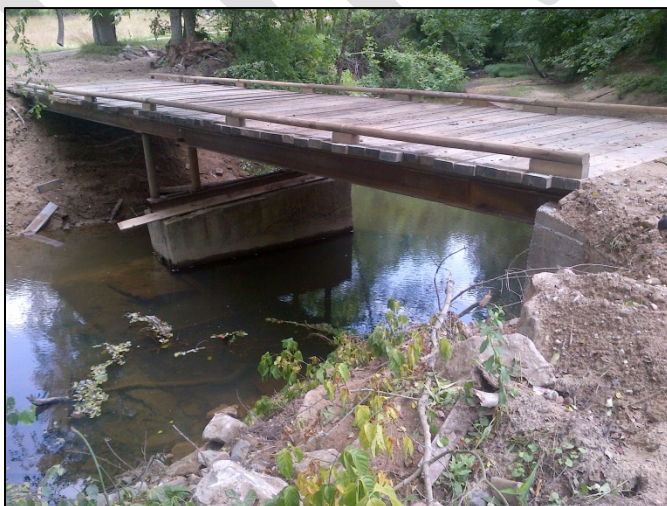
37. This site's bridge crossing was damaged along Little Harts Creek. There is washed out wing walls, bank erosion and scouring around abutments. Bridge services one home. The coordinates are: 38.07967°, -82.08877°; elevation: 593'. Address: 539 Guyan River Road, Ranger, WV 25557, Lincoln County.

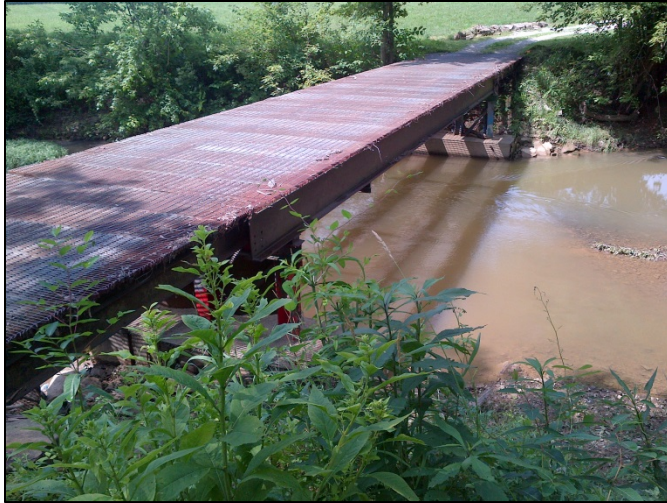
38. This site's metal grate bridge crossing was damaged along Mud River. There is bank erosion and scouring around abutments. Bank stabilization with rocks around abutments is needed. This bridge services three homes. Coordinates: 38.31169°, -82.108156°; elevation: 610'. Address: 736 Lower Mud River Road, West Hamlin, WV 25571, Lincoln County.
