Private Water Crossing Report

FEMA-4219-DR-WV

July 7, 2015

This report was developed by Allen Graybill, FEMA Reservist, who was deployed as a Hazard Mitigation Program Support Manager to the Joint Field Office in Charleston, West Virginia during the response and recovery of FEMA-4219-DR-WV in May 2015.

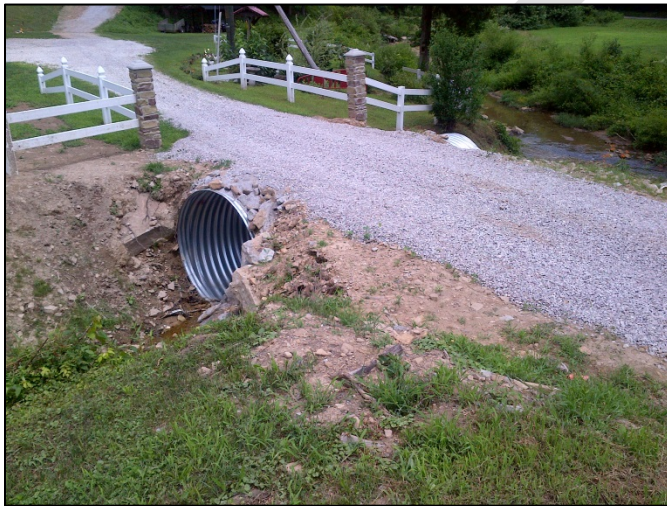
38. This site's metal grate bridge crossing was damaged along Mud River. There is bank erosion and scouring around abutments. Bank stabilization with rocks around abutments is needed. This bridge services three homes. Coordinates: 38.31169°, -82.108156°; elevation: 610'. Address: 736 Lower Mud River Road, West Hamlin, WV 25571, Lincoln County.

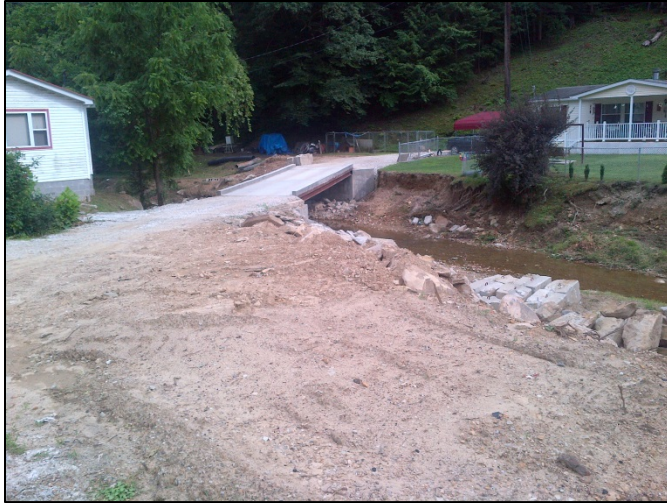
41. This new bridge replaces washed out water crossing along the Peter's Cave Fork. Site work, approaches, with new concrete abutments and decking has been completed. This bridge services one home.

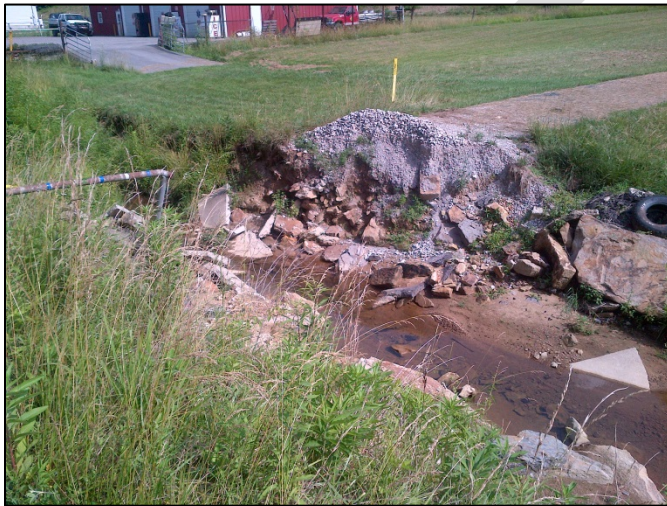
42. This bridge crossing was severely damaged and removed along the Peter's Cave Fork. Site work, approaches, with new abutments, wing walls and decking is needed along with necessary bank stabilization. This bridge services one home. The coordinates are:

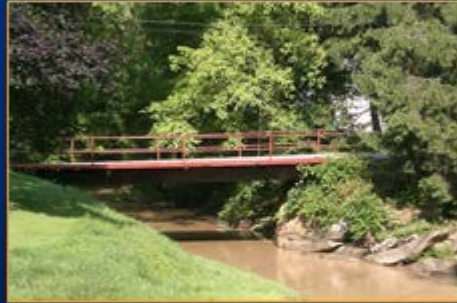
Bridges

- If designed and constructed properly, bridges are preferred to culverts and low water crossings, since bridges can avoid altering the natural flow of the water
- Handrails or guardrails should be installed where necessary

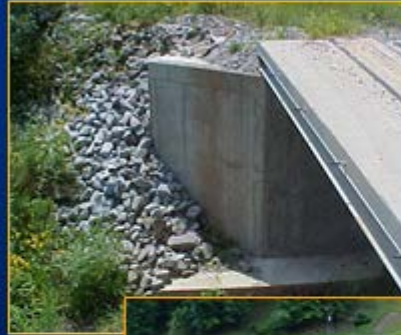
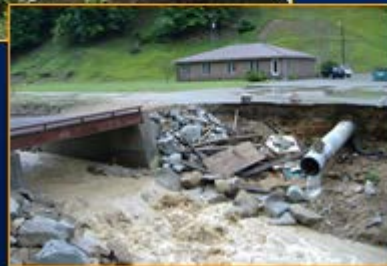
Bridges

- Install wing walls to direct the water flow into the bridge opening
- Wing walls help avoid potential erosion, scouring and structural failure
- Lack of wing walls can cause loss of bridge approach

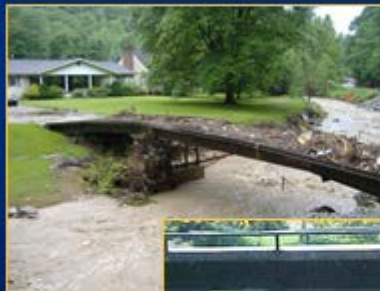
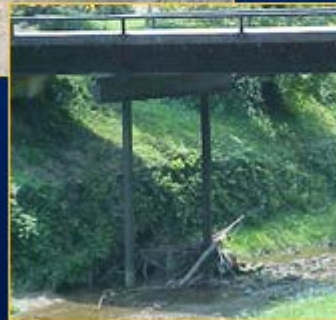
Bridge Crossing Problems

- Strive to avoid locating abutments and piers in the water channel
- Support piers located in a stream bed will create scouring and debris catch
- Causes a weakening of the structural integrity of the bridge

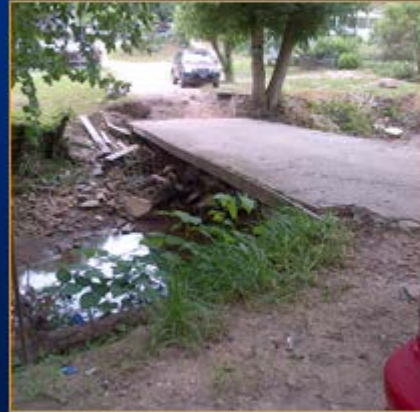
Bridge Crossing Damage

- Bridge collapsed at property side with deck damage, scouring and loss of bridge approach
- Establish better water flow clearance if possible
- Bridge needs wing walls and new abutment or abutments
- Bank stabilization needed
- Add curbing and/or railing

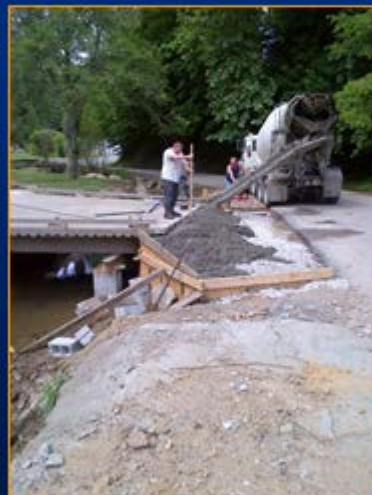
Bridge Crossing Repairs

- Bridge collapsed at road side with deck damage, scouring and loss of bridge approach
- Bridge end jacked up and supported temporarily
- Pour new supports and deck with rebar, wing walls
- Riprap/Gravel fill and bank stabilization

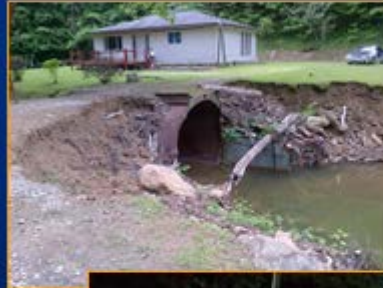
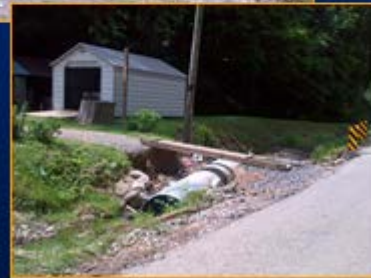
Culvert Repairs

- Repairs could involve installation of geo-tech fabric and riprap rock to stabilize bank and avoid future scouring and erosion
- Possible increase in culvert size to increase volume and velocity of flow will require an H & H study

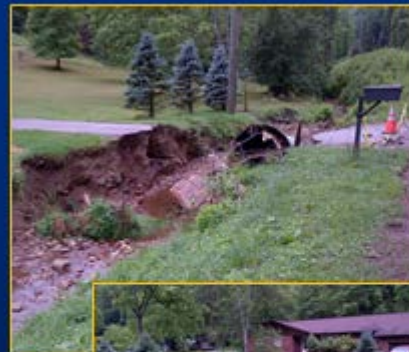
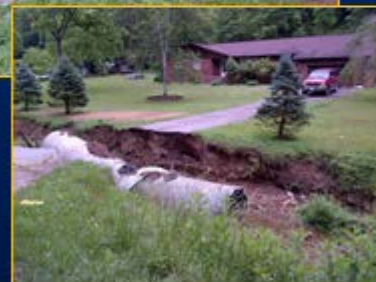
Culvert Repairs

- Repair to blown out culvert could involve replacing the undersized metal culvert with a bridge
- Bridge will maintain the original watercourse channel bed
- Bridge will provide better capacity to accommodate high water flow
- Site space permits avoiding stream bed encroachment

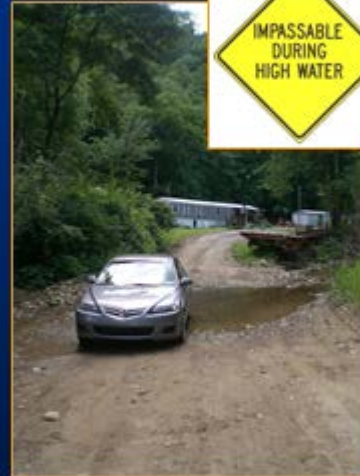
Low water crossings

- Suitable for low volume roads and relatively low volume water flow
- Not for servicing occupied dwellings
- Install proper signage warning of the dangers of high water
- Utilize only with suitable stable streambed and banks
- Unvented fords should have water depth flow under 6 inches
